TIMBER PEST DETECTION REPORT

Prepared By PEST INSPECTION SERVICES Pty Ltd

ADDRESS OF PROPERTY INSPECTED: **456 Any Street, Anywhere**

DATE OF INSPECTION: **12th March 2011**

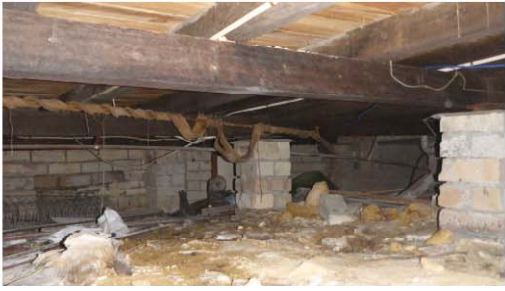
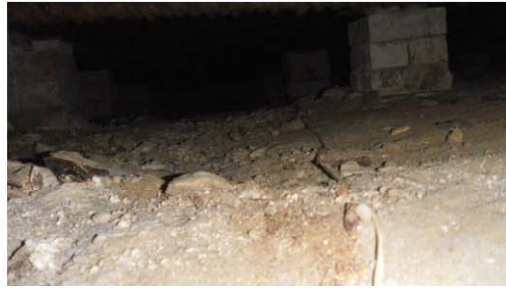
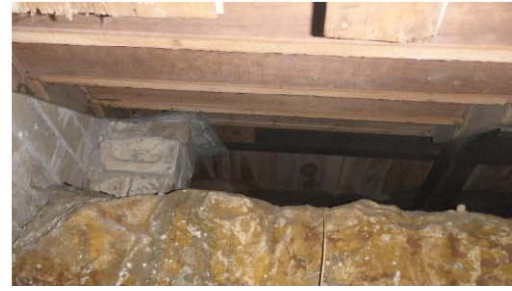
Sample photos of sub floor

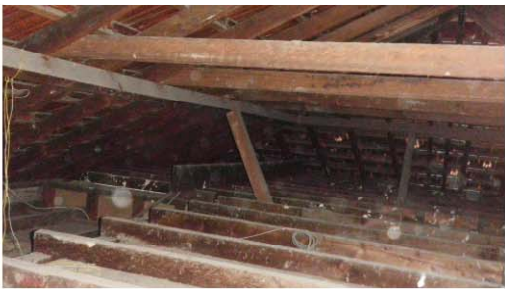
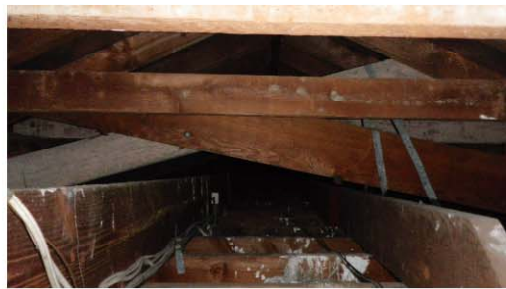
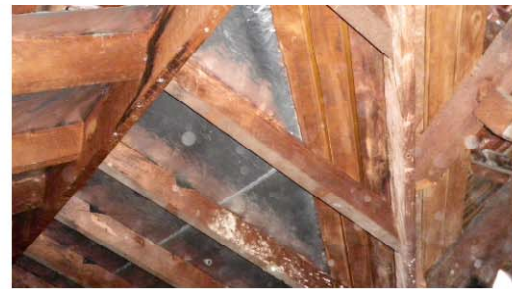
Sample photos of roof space
